## Introduction

Thank you for designing with the Zynq® UltraScale+™ MPSoC family. Although Xilinx has made every effort to ensure the highest possible quality, the devices listed in [Table 1](#) are subject to the limitations described in the following errata.

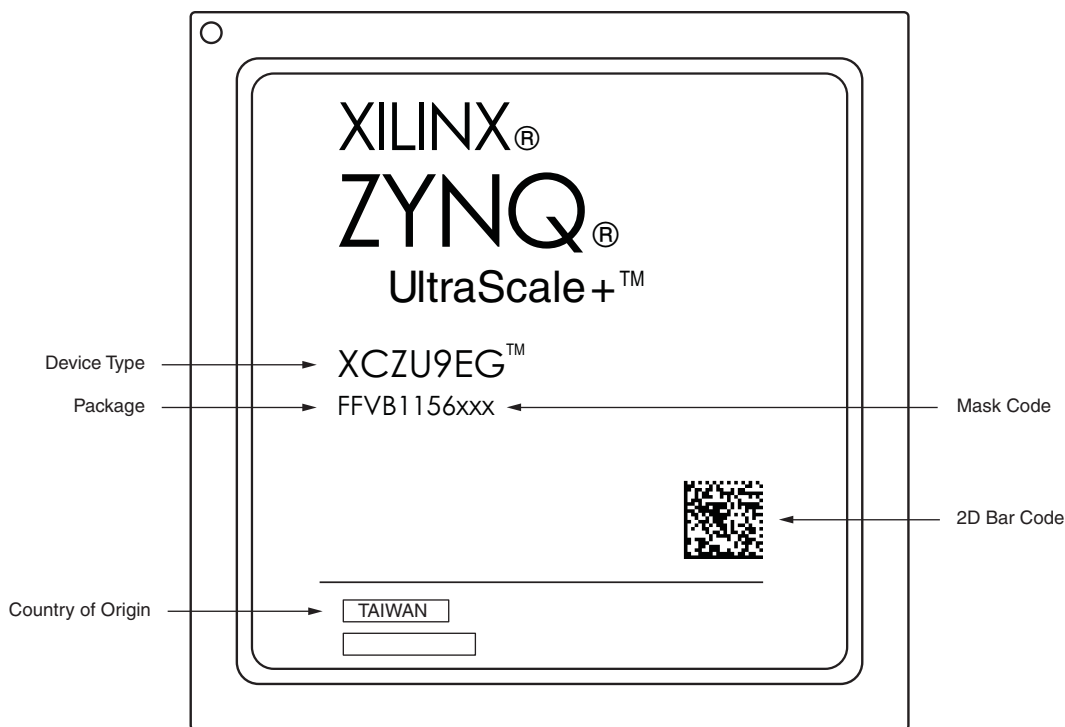
Figure 1: Example Device Top Mark

Figure 1 shows an example device top mark for the devices listed in Table 1. The device type, package, and mask code might not appear on some devices. Use the 2D bar code to find device properties via the device lookup tool: <https://xapps9.xilinx.com/2dbarcode/>.
